## Water Compliance Inspection Report

**NPDES  
Compliance Inspection Report**

**Bloks Evergreen Dairy, Inc.**

**March 29, 2010**

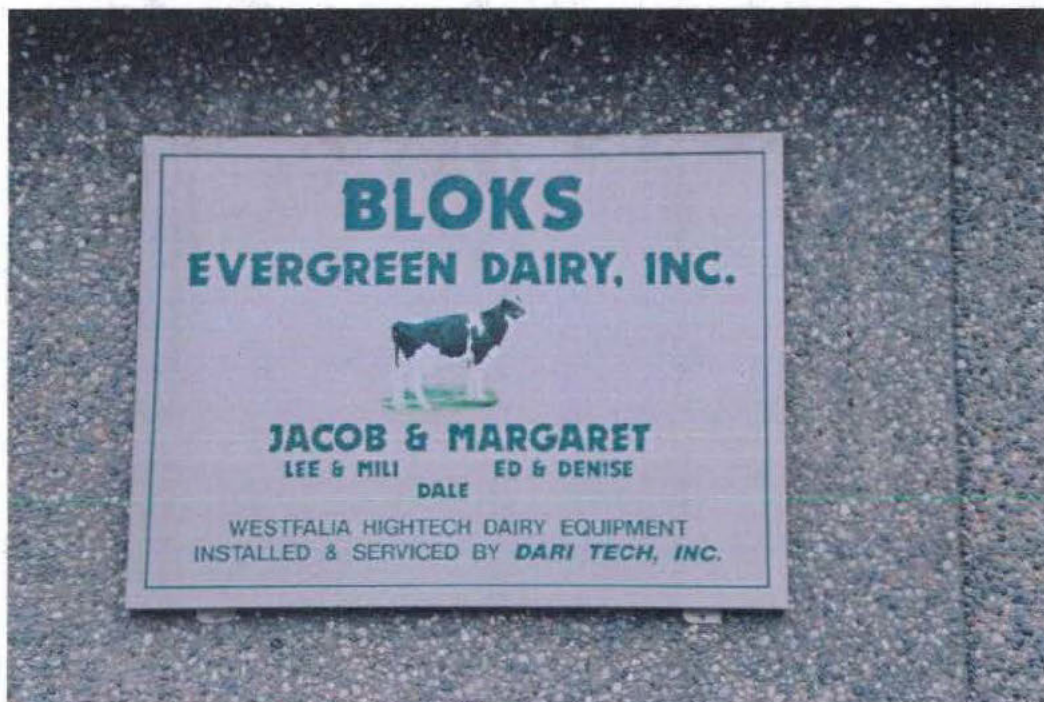
This is a dairy facility that the Blok brothers have been operating for approximately 38 years, since 1972 (photo 1).

Photo 1. Bloks Evergreen Dairy sign.

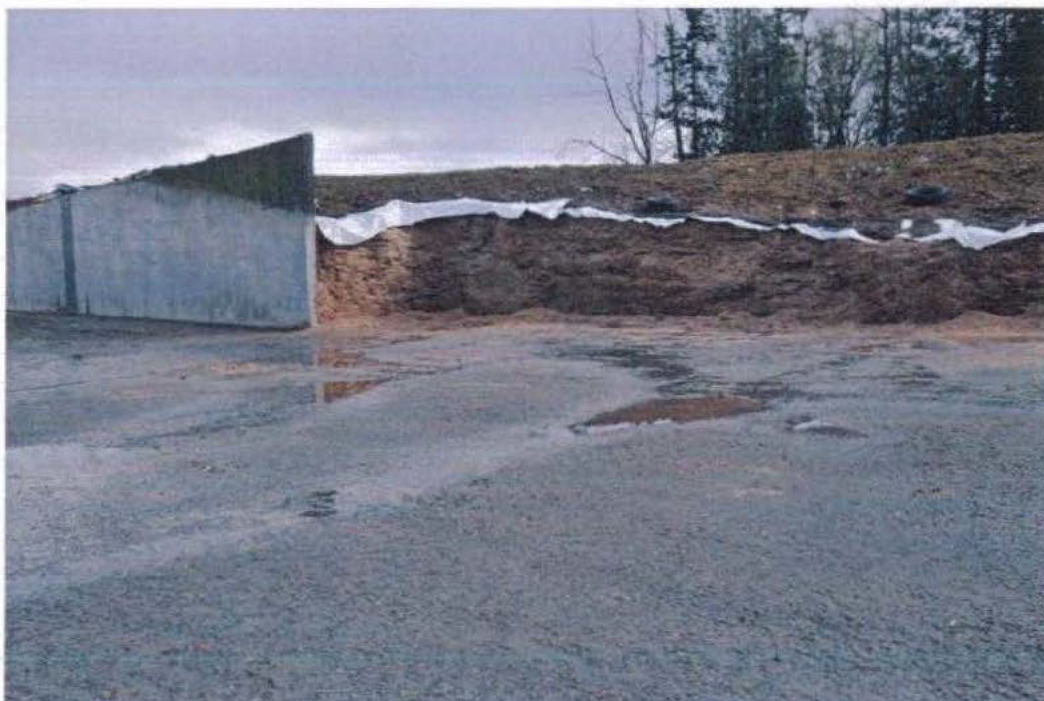
The feed was stored in bunkers and was covered with either a tarp or a roof (photo 2).

Photo 2. Silage storage, covered with a tarp.

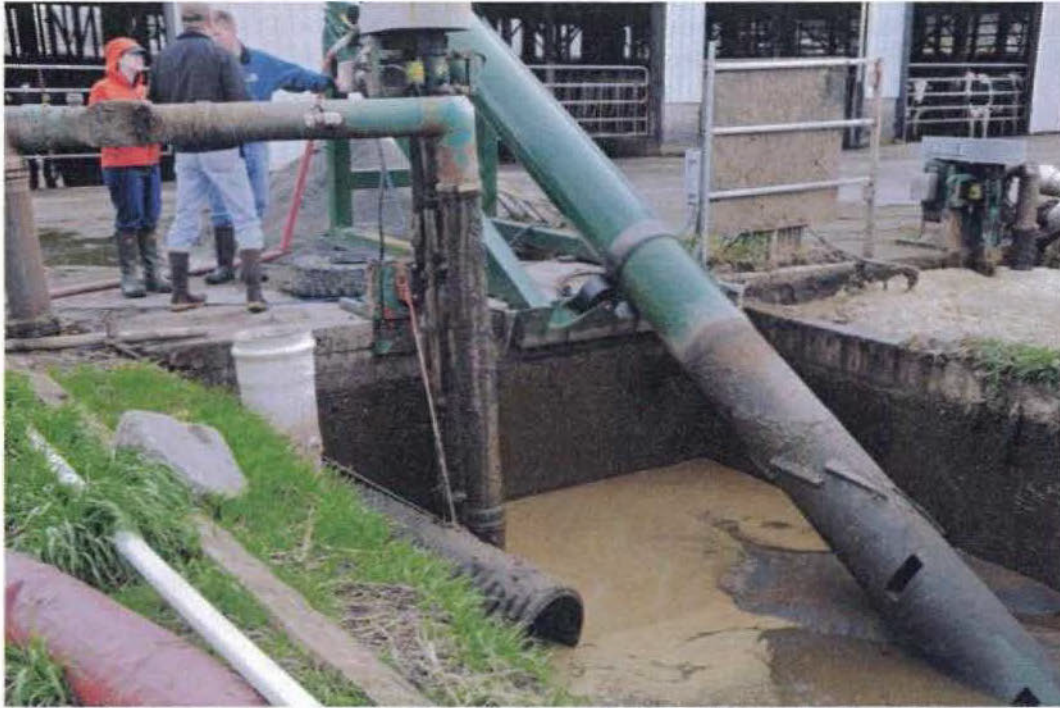
Waste from the barns is scraped into the below-ground storage tank. Sand, which is used as bedding, is also scraped with the waste. To separate the sand from the dairy manure, a screw auger is used to remove the sand while allowing the solid and liquid manure to remain in suspension (photos 3). The sand is then spread out and flushed with wastewater from the barns to remove any remaining solids, after which it is allowed to dry and is re-used for bedding (photo 4). The solids and liquids are routed to a solids separator. The liquids are circulated through the system to keep the solids suspended, and are eventually routed into the lagoons for storage (photo 5).

Photo 3. Screw auger used to remove sand from solid and liquid manure.

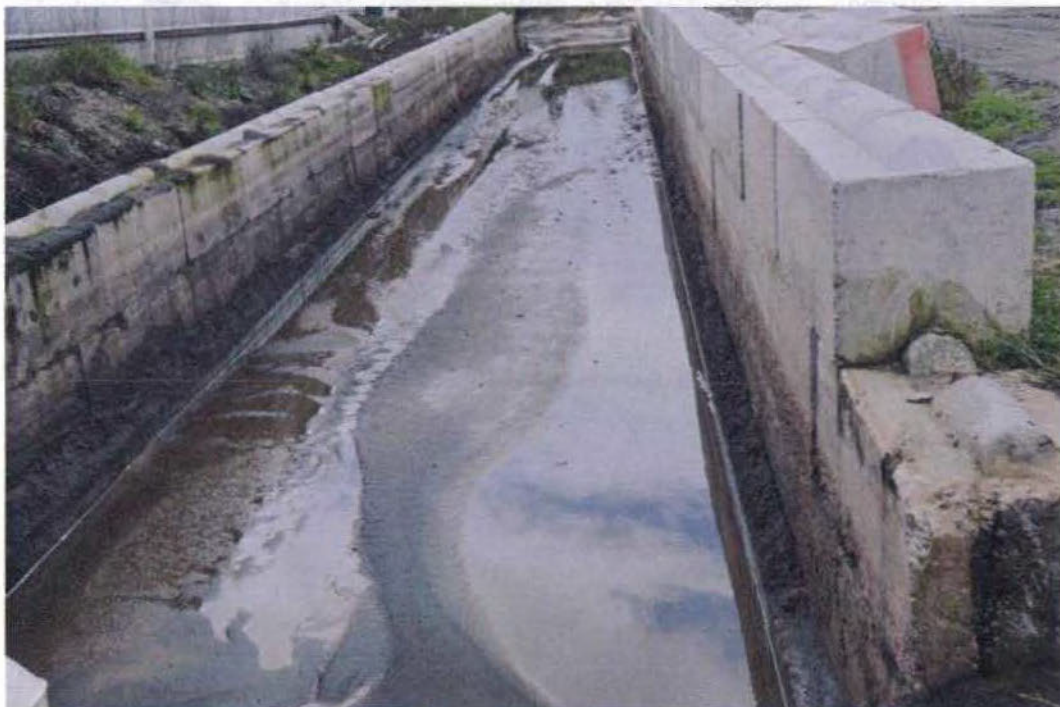
Photo 4. Sand being flushed with water to remove any remaining solids.

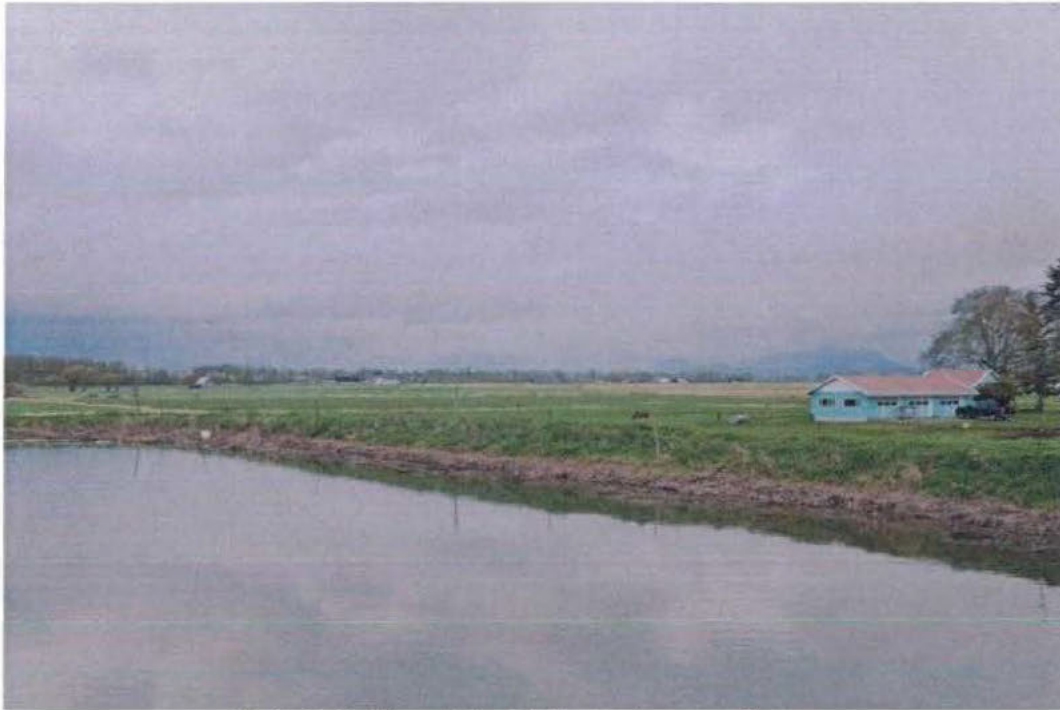
Photo 5. Northeast view of the eastern-most lagoon.

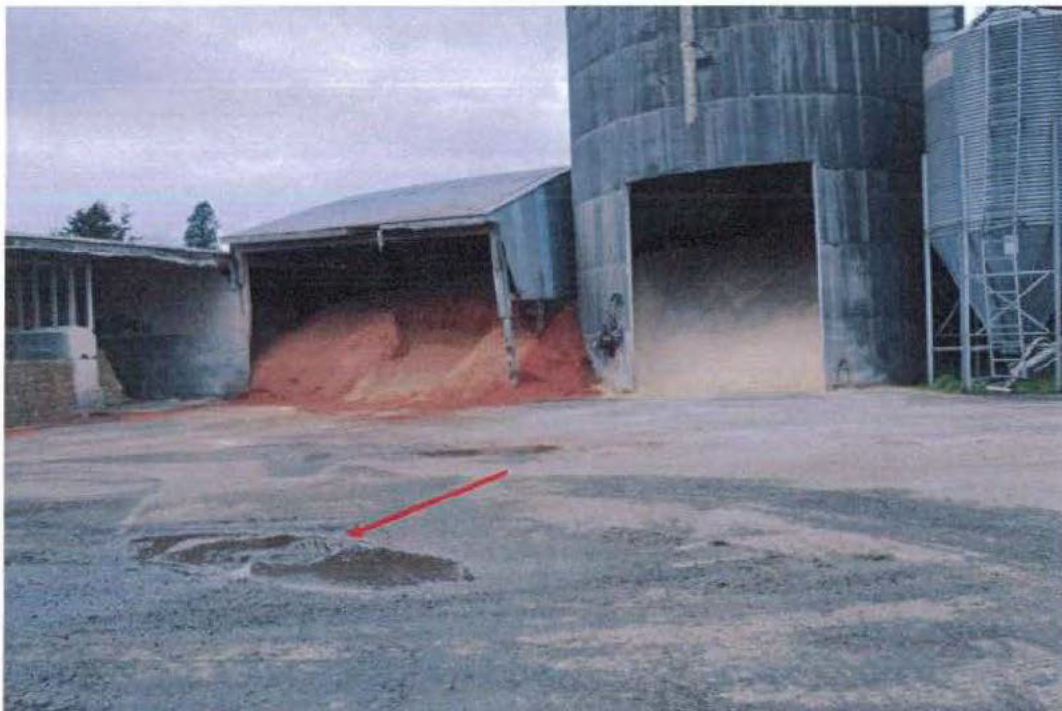
Some stormwater flows from roof gutters into a nearby ditch; most of it eventually filters into the groundwater. Any stormwater that flows through the feed storage area is collected in a drain that flows into a storage lagoon to prevent runoff of silage leachate (photo 6).

Photo 6. Feed storage area, with stormwater drain indicated with the red arrow.
